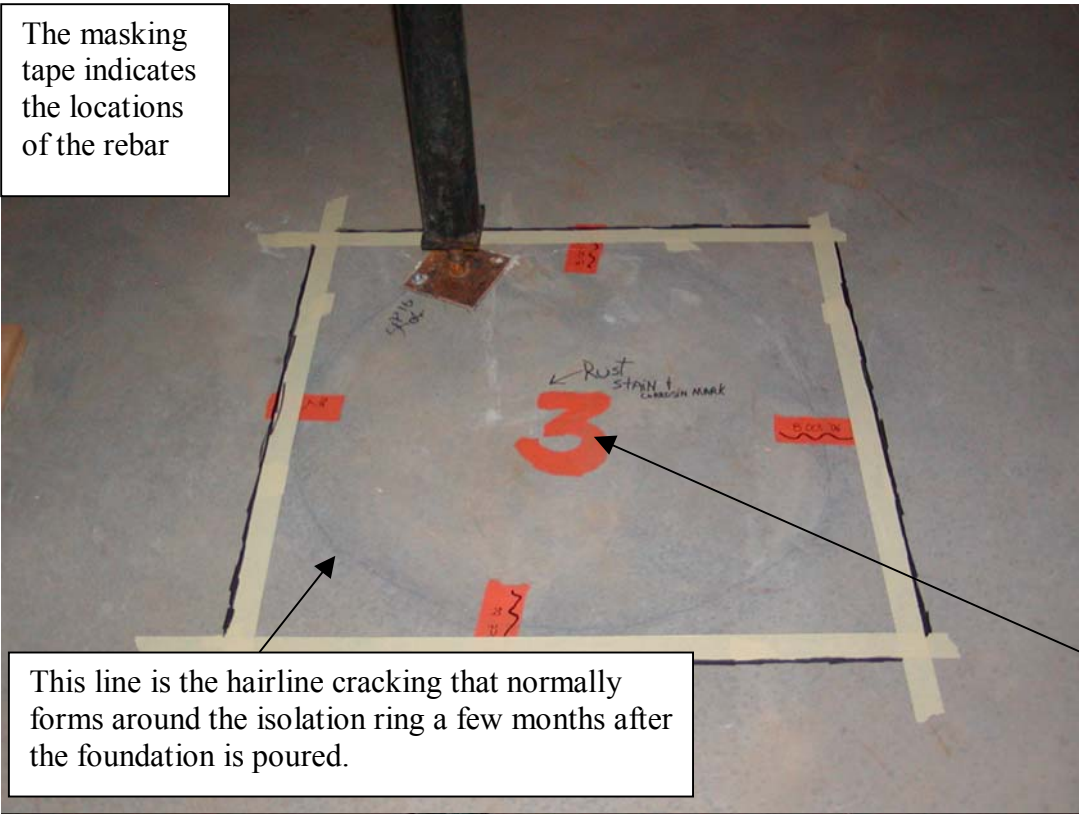
The masking tape indicates the locations of the rebar

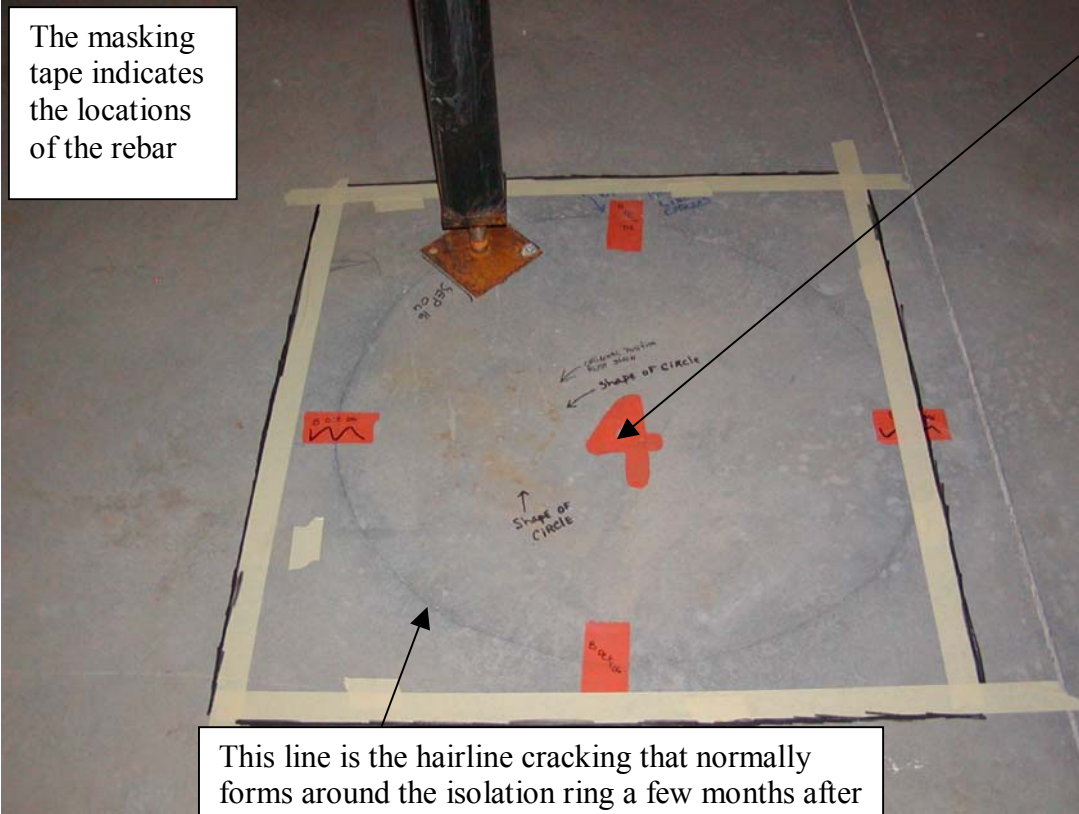
This line is the hairline cracking that normally forms around the isolation ring a few months after the foundation is poured.

In a perfect Pulte world, the home's support columns should be sitting somewhere near the painted number.

The masking tape indicates the locations of the rebar

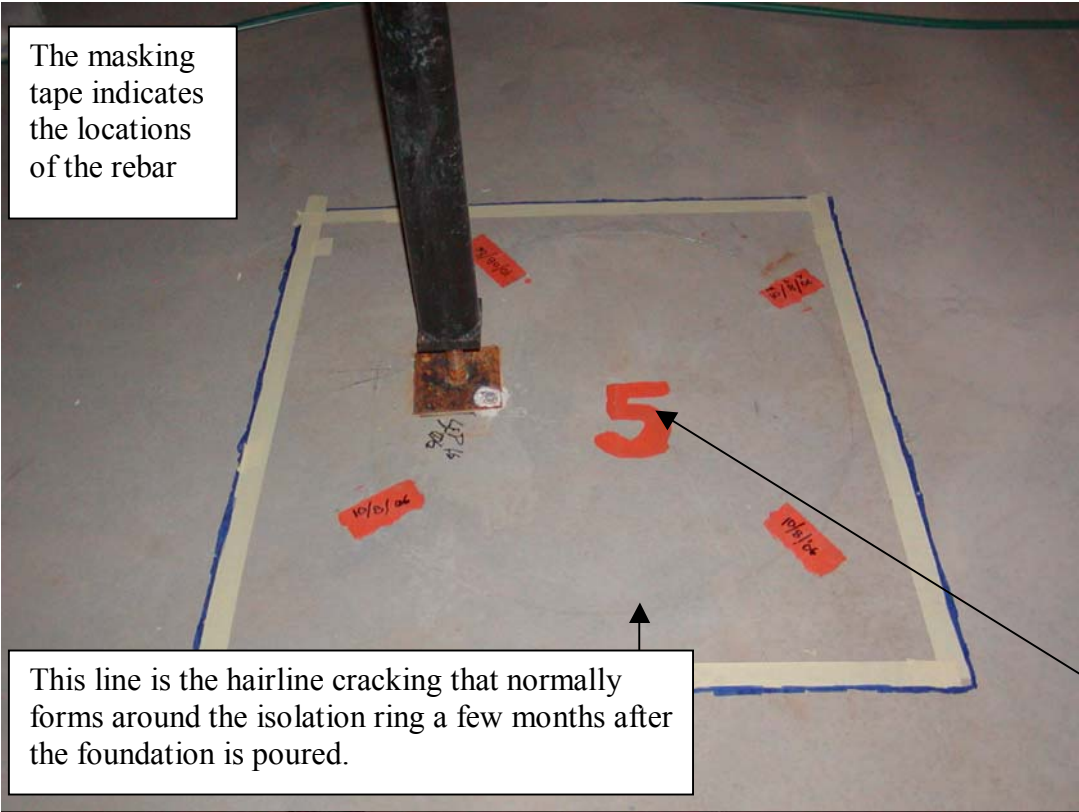
This line is the hairline cracking that normally forms around the isolation ring a few months after the foundation is poured.

The masking tape indicates the locations of the rebar

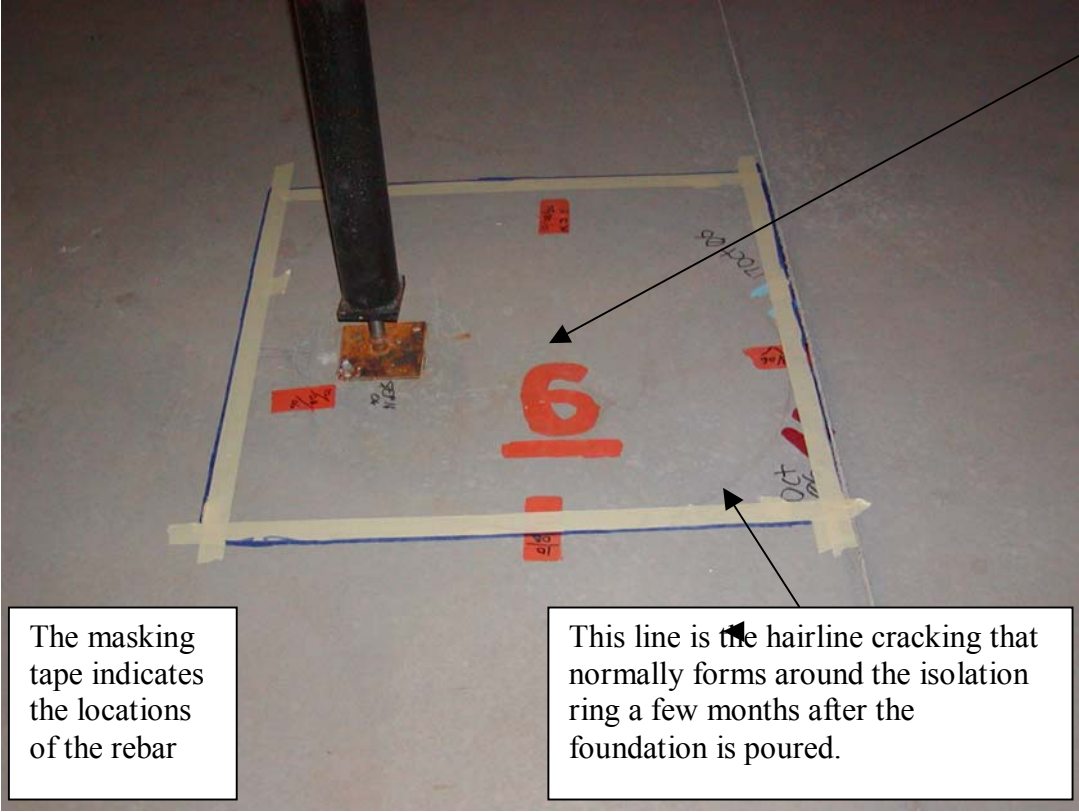
This line is the hairline cracking that normally forms around the isolation ring a few months after the foundation is poured.

In a perfect Pulte world, the home's support columns should be sitting somewhere near the painted number.

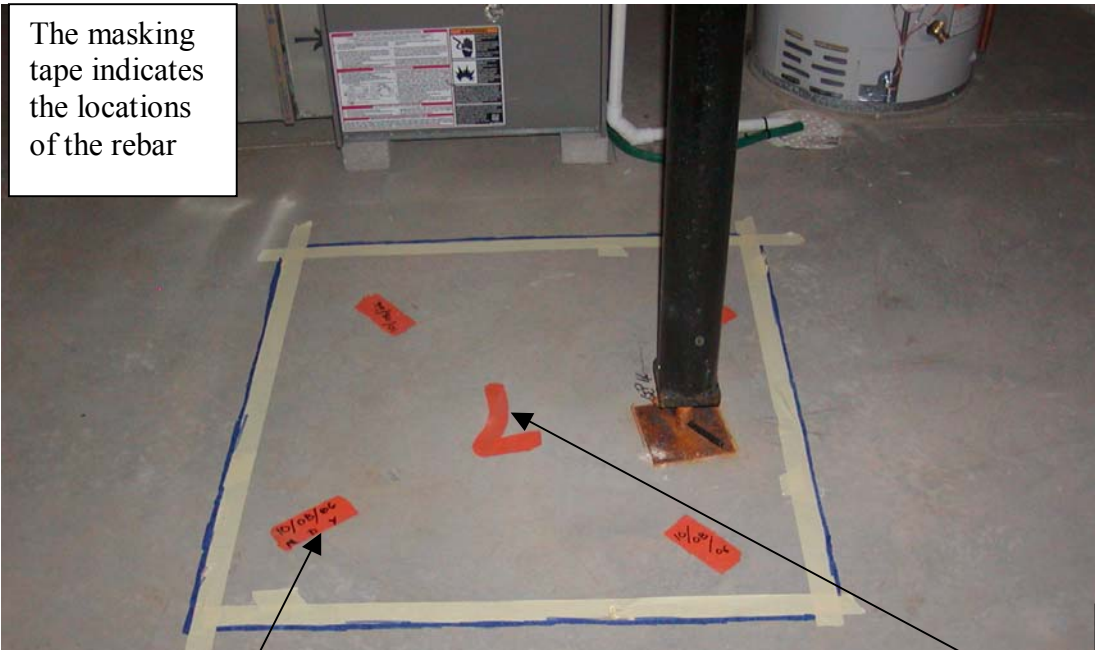
The masking tape indicates the locations of the rebar

This line is the hairline cracking that normally forms around the isolation ring a few months after the foundation is poured.

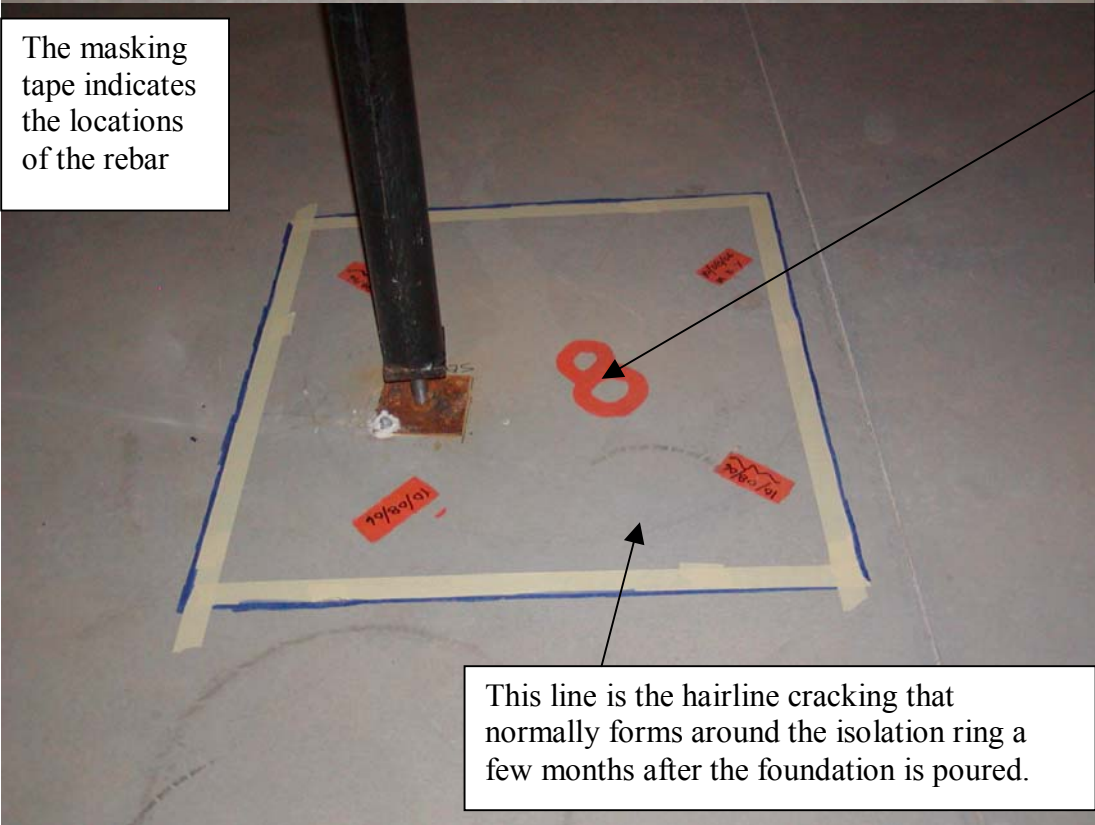
This line is the hairline cracking that normally forms around the isolation ring a few months after the foundation is poured.

In a perfect Pulte world, the home's support columns should be sitting somewhere near the painted number.

The masking tape indicates the locations of the rebar
